CAA112(r) INSPECTION REPORT

Name: TURPAK FOODS and COMPANIES	
Address: 6201 MacArthur Street Sioux City, IA 51111	Date of Inspection: 02/06-07/18
County: WOODBURY	Case No: 18IA0207
Phone: 712-224-6619	RMP No: 1000 0003 8719
High Risk: No	FRS No: 1100 1002 8549
CAA Title V: No	Program Level: Program 3
Mailing Address: 6201 MacArthur Street, Sioux City, IA 51111	
Process: Anhydrous ammonia refrigeration for perishable prepared food manufacturing, meat processed from carcasses, and poultry processing.

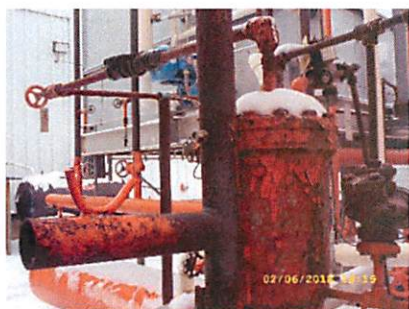
4. TURPAK FOODS and COMPANIES failed to meet recognized and generally accepted good engineering practices as required by 40 CFR 68.65(d)(2), specifically: equipment outside and inside facility had rust and scale, needing repainting; eyewash/safety showers, one non-functional (inside machine room) and another too far away (outside the machine room)(ANSI/IIAR 2-2014, sect 6.7.1 and 6.7.3); audible and visual alarms inside machine room and outside of both doors to the machine room missing or not having both functions (ANSI/IIAR 2-2014, sect 6.13.1 (1 and 3)); exhaust ventilation duct vents to outdoors with less than 20 feet from openings into the building (ANSI/IIAR 2-2014 sect 6.14.3.4).

Rusted equipment
outside TPF facility

Post-inspection, I received information from TPF regarding maximum intended inventory, material and energy balances, and corrective actions taken or planned for RAGAGEP issues.

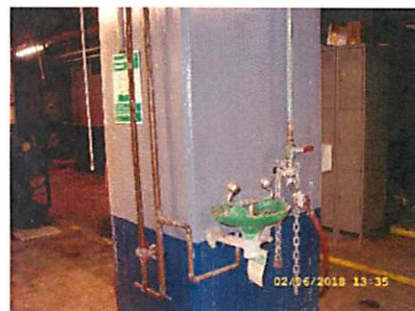
Non-operational eye
wash station in TPF
engine room.
